40 YEARS OF PERFORMANCE DESIGNED SOLUTIONS

APPLICATION: **STEEL FOUNDRY**

LOCATION: **MIDWEST USA**

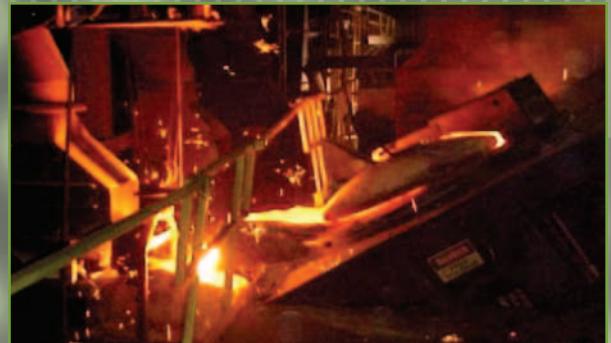
Reliable, consistent and cost effective refractory performance in the coreless furnace requires a "systems approach" that involves the refractory components and installation process.

Area opposite spout furnace #8-54 heats

Hotface surface lining furnace #6-185 heats

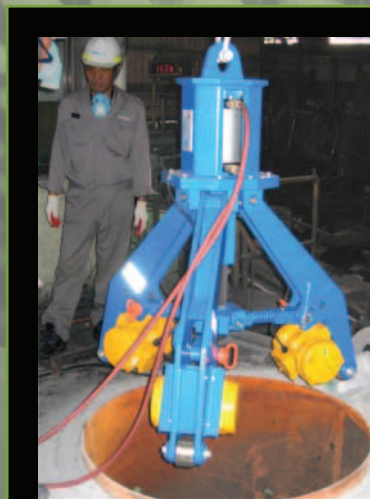
The "systems approach" involves the installation process, and URC worked with the customer to select a specific vibrator design that optimized the process.
