40 YEARS OF PERFORMANCE DESIGNED SOLUTIONS

CUPOLA STACK MAINTENANCE UNI-BRADE AR-85

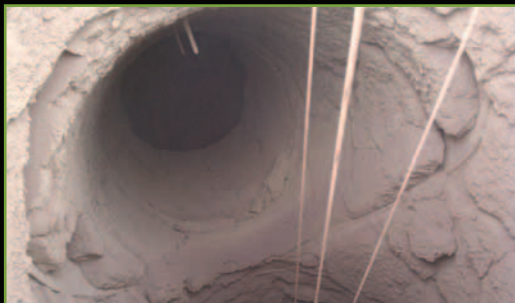
BEFORE gunning UNI-BRADE AR-85 on the joint where the crossover meets the upperstack.

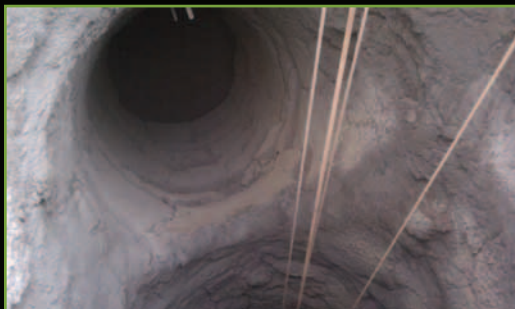
AFTER gunning UNI-BRADE AR-85.

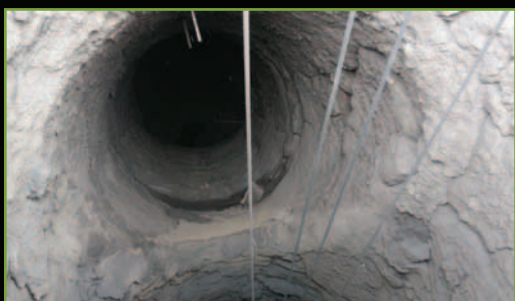
4 MONTHS AFTER, the joint is still in excellent shape.
